Pre-Passage Rigging Checks

Prior to any major passage, I devote a couple of days checking the systems aboard Nine of Cups. We'd just completed a tough Indian Ocean passage, and after spending a few months making repairs and seeing the sights, it was time to leave South Africa and begin our crossing of the Atlantic. The engine, prop shaft seal, steering, bilge pumps, nav lights, thru-hulls, windlass, and a host of other items were all scrutinized and/or tested, but at the top of the list were the rigging checks.

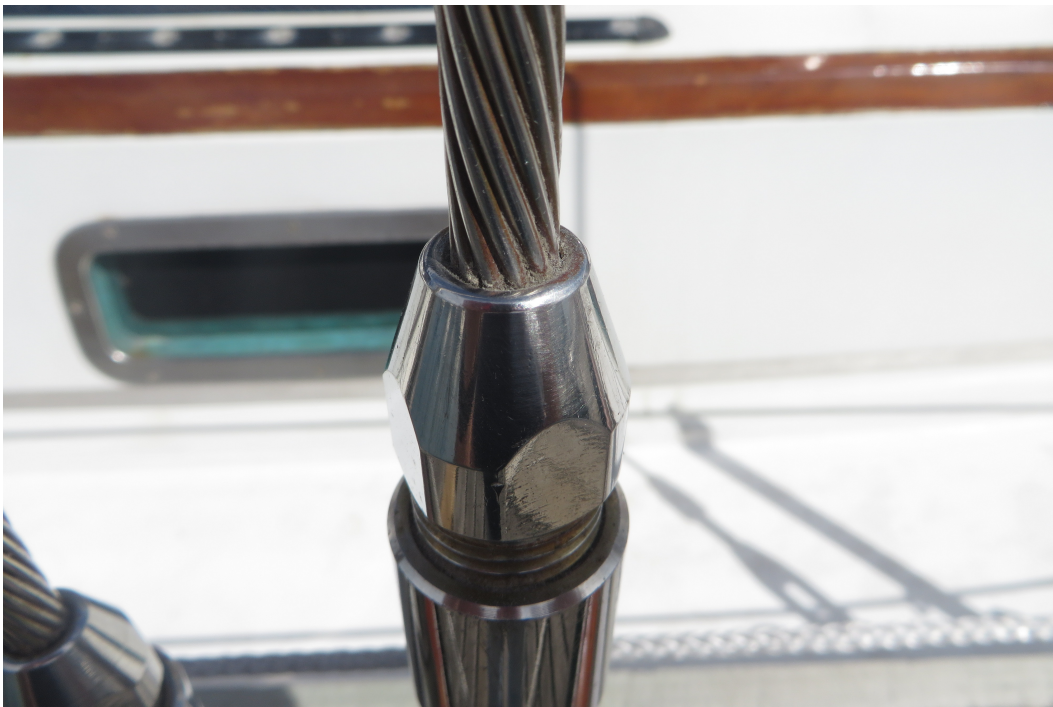
I do a close eyeball check on all the fittings and wire before cleaning the rust – sometimes the rust can point to a problem. Then I clean the fitting with a good metal wax (I like Collinite metal wax) and inspect the part again, looking for any cracks, distortions, worn or stressed parts, elongated holes, missing split pins, loose or missing bolts, etc. - in general, anything that doesn't look right. I also look closely at the wire for any strands that look cracked or broken. We have Stalock fittings throughout, but if we had swaged fittings, I would also check for cracked or swollen fittings. The aluminum mast probably has a hundred stainless screws attached to it, all of which are subject to galvanic corrosion, so I check each of these. A sure sign is bubbling or swollen paint around the screw head.

Stalock fitting

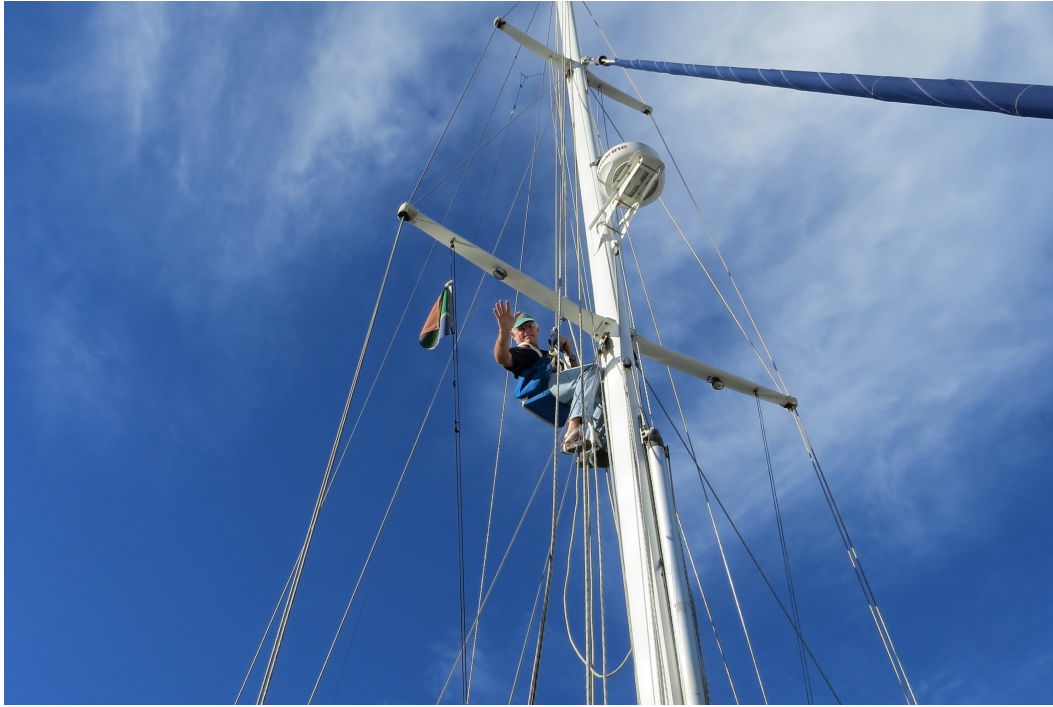
Up the mast

I usually go straight to the top of the mast and slowly work my way down. I use a bosun's chair with side pockets and have a separate safety harness on a second halyard as a backup.

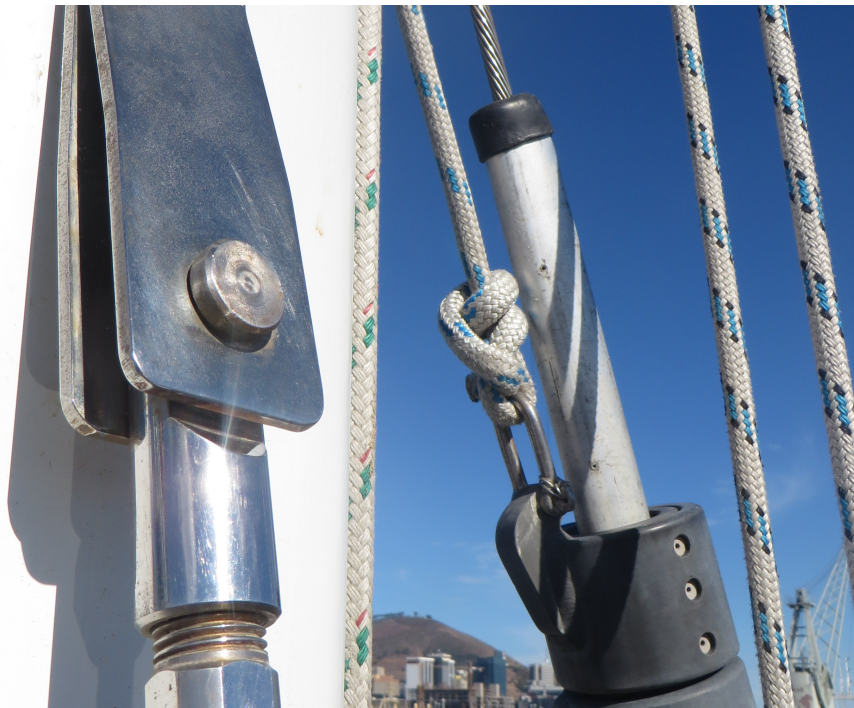
In addition to the general checks, I check the sheaves for cracks and the halyards for any chafing. If the upper furler bearings bind, the halyard will wrap around the furler, so I check that the upper swivels move freely. I check that all shackles are properly seized and that any knots look good.

Furler

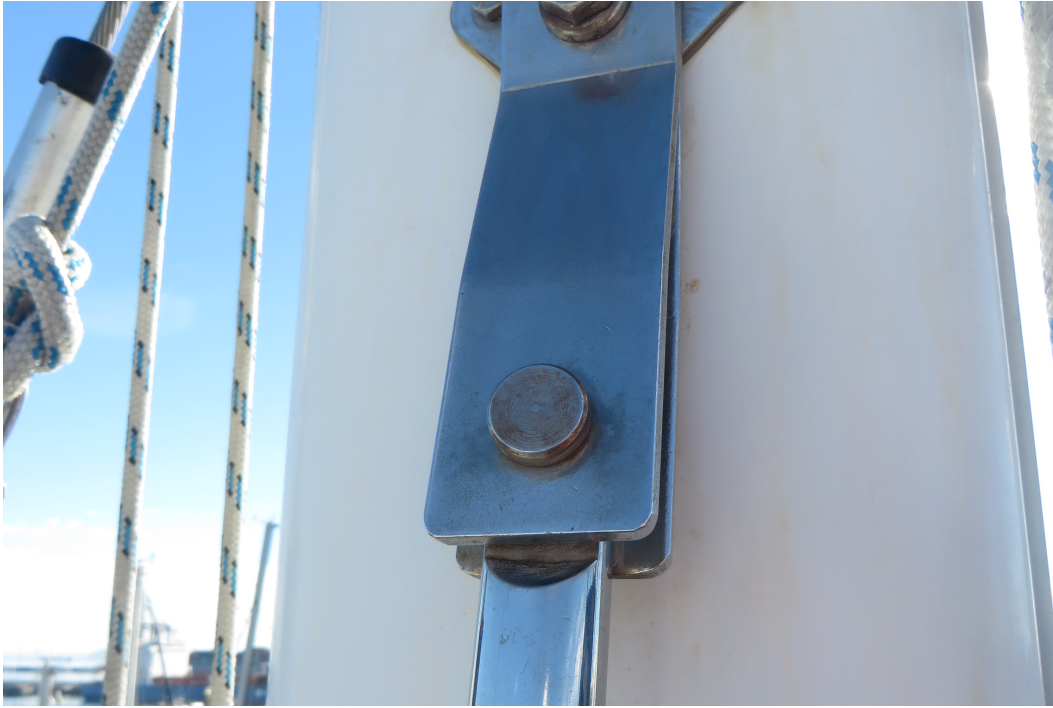
One of many tangs

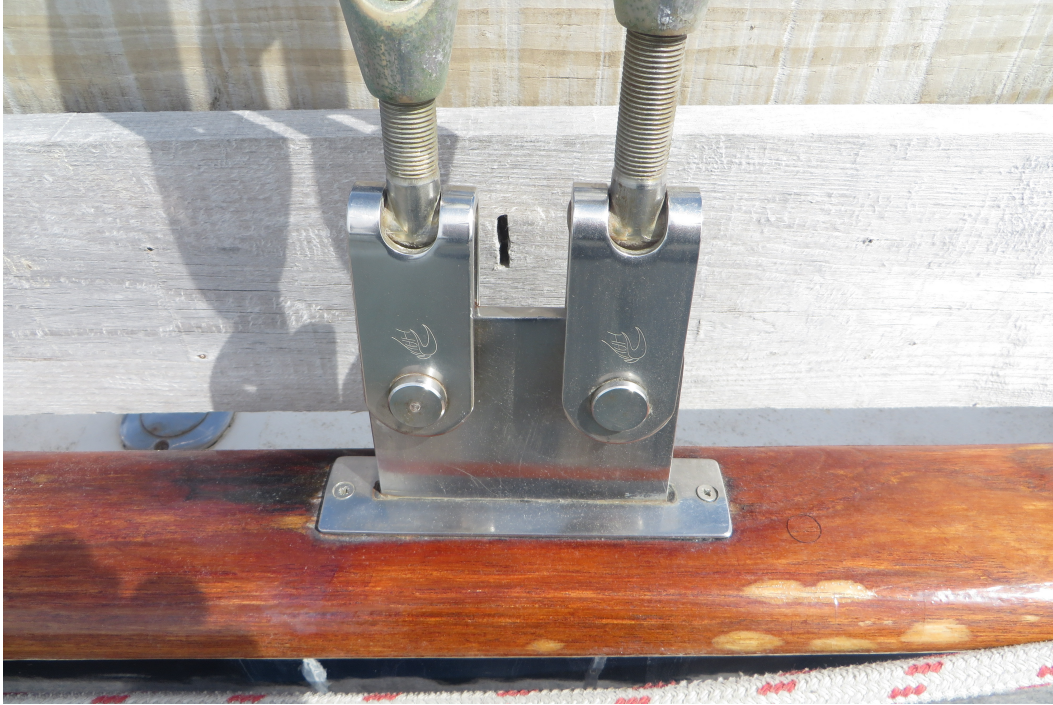
Our chain plates pass through the caprail and are glassed into the hull. Except for the very tops, which are exposed, they are virtually impossible to inspect. I check them closely, looking for any hairline cracks, elongated holes, or signs of moisture that might be making its way downward.

Chainplates

A potential show stopper was also discovered, however. The chainplates on the starboard side were showing some evidence of water ingress and possible corrosion. The chainplates are stainless steel, which is generally very corrosion resistant and performs quite satisfactorily in marine environments. It is very susceptible to crevice corrosion, though. Crevice corrosion is a localized form of attack which is initiated when the metal comes in contact with moisture when there is a low availability of oxygen – such as in a crevice. If moisture, especially saltwater, makes its way past the caulking around a chainplate and lies against the stainless, a perfect environment for crevice corrosion develops. Since the internal chainplates on Nine of Cups could not be inspected without literally dismantling the cabinetry in the saloon, there was no easy way to determine how much corrosion had developed.

Losing a chainplate would almost certainly lead to losing the mast – not a pleasant prospect anywhere, least of all in the middle of a major ocean crossing. Many sailboats of the same vintage as Nine of Cups that have glassed in chainplates have replaced them with external versions - heavy duty stainless steel straps that are attached to the exterior of the hull, and thru-bolted to a backing plate inside. As painful as it was, we made the decision to replace the chainplates before departing Cape Town.

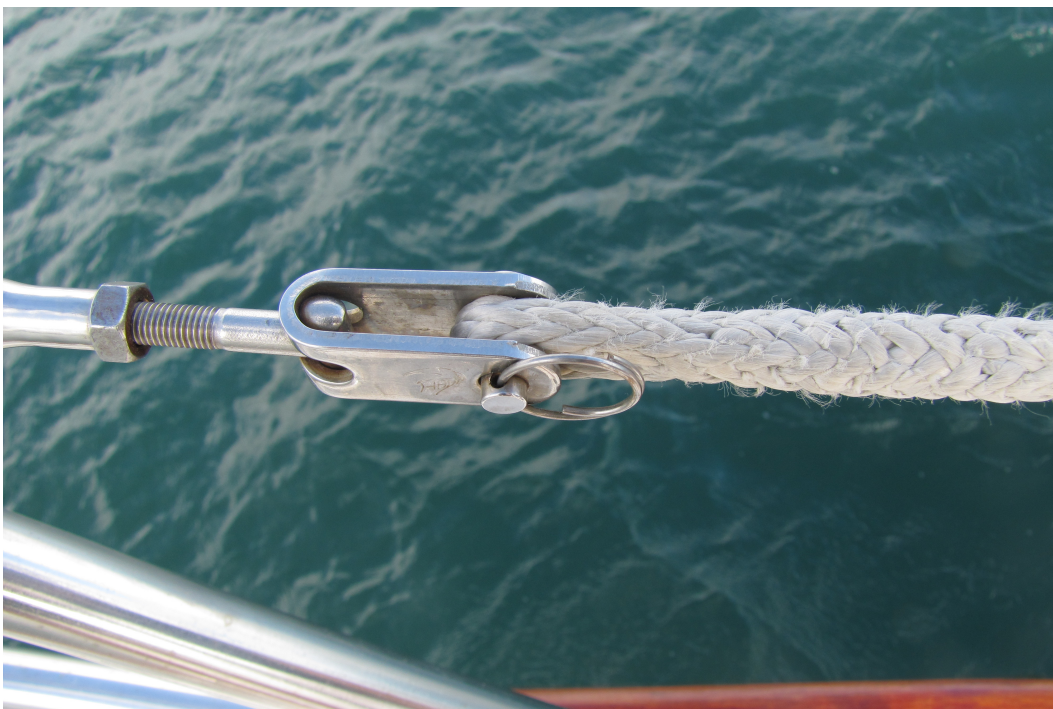
We have Dyneema (actually Amsteel) lifelines, and really like them. They have two issues, however. First, Dyneema exhibits creep, which means the lifelines continue to slowly stretch over time and need to be re-tensioned every few months. Second, the Dyneema should be replaced every 3-5 years, due to UV degradation. The degradation is not readily apparent, so it is important to keep track of how long they have been in place and when they should be replaced. Prior to the Dyneema, we had the usual swaged stainless wire lifelines, and these were carefully inspected for any signs of broken wires, cracked swages, etc. I also check for any wear at the stanchions, and check all turnbuckles, pelican hooks and shackles for cracks. All split rings should be in good shape and facing inboard. Inspect the stanchions and bases for cracks or looseness.

Our Dyneema lifelines

So, what did I discover from our rigging check? Several small issues were corrected: Lifelines re-tensioned; several split rings needed replacing; first reef line, port side was chafed - I was able to remove a few feet from the end and re-use it; a few screws were missing or loose on the stanchion bases; several lines needed re-whipping.
